REEFER LINK BATTERY CIRCUIT PROTECTION DECISION TREE

Does the Reefer Kit fall under remediation?

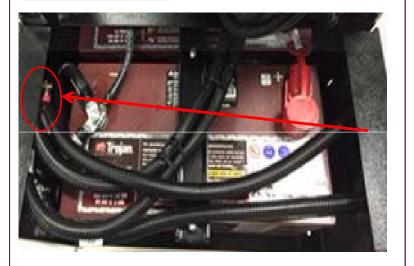
Series 1000

The positive cable will be installed from the Reefer Link connector (on right) to the positive connector that routes to the battery bank (circled).

If your inspection does not satisfy the OKAY wiring, you will need to remediate the unit. Remediation kits can be ordered by logging into the IFS Portal – Dealer Log In.

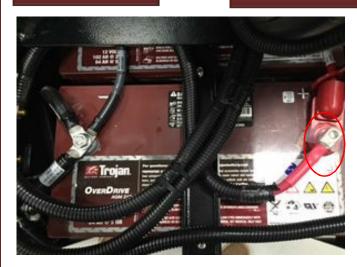
Series 1000

NOT OKAY

The positive cable is installed from the Reefer Link connection directly to the positive connector on the battery bank (circled).

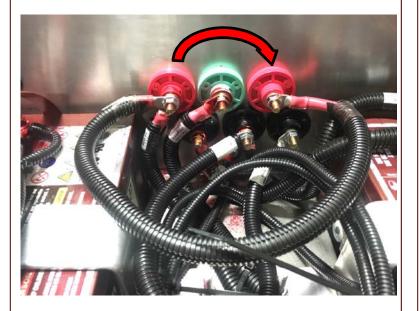
OKAY

The positive cable will be installed from the Reefer Link connector to the positive connector that routes to the battery bank. Battery Box

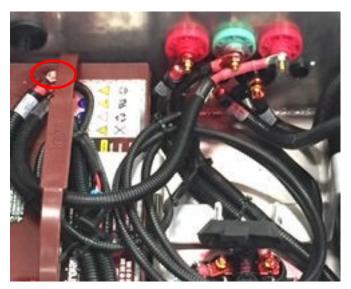
NOT OKAY

The positive cable is installed from the Reefer Link connector directly to the battery positive terminal (circled).
